So Metal

The Square PHX History Blog

Written by Heather Roberts, Research Historian

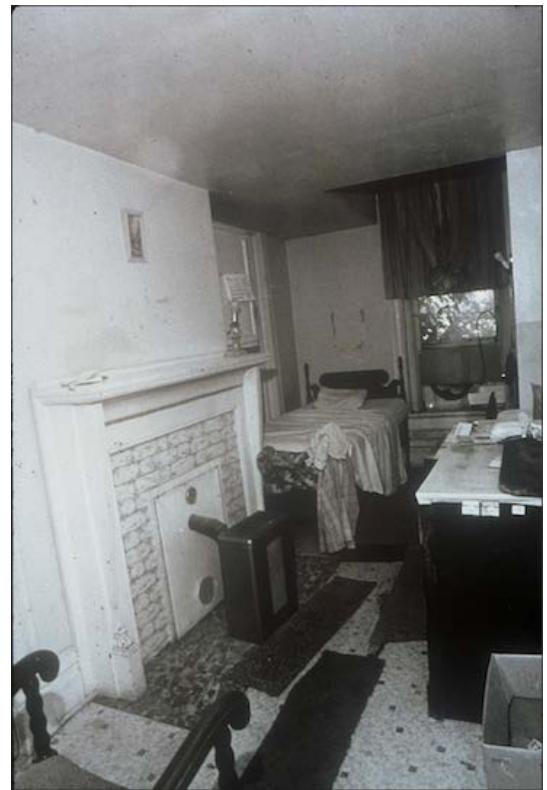
The Rosson House family parlor, prior to restoration.

During restoration of the home, workers tore out the additions and found the original ceilings in bad shape:

"The pressed tin ceilings were badly chipped and had multiple layers of paint on the panels creating an "alligator" appearance. Several samples of paint were removed from the panels (the flat and raised areas) and looked at microscopically. The chips were sent to a paint laboratory in California for chemical analysis as to content and sheen of the bottom layer. Each room had a first layer of a soft green primer paint followed by an application of lead-based paint in a medium sheen. Next, the paint chips were sent to an expert with the National Parks Service in Denver who color-coded them with the Munsell System for coding historical paint colors. The paints were then reproduced locally; however, the lead content was eliminated.

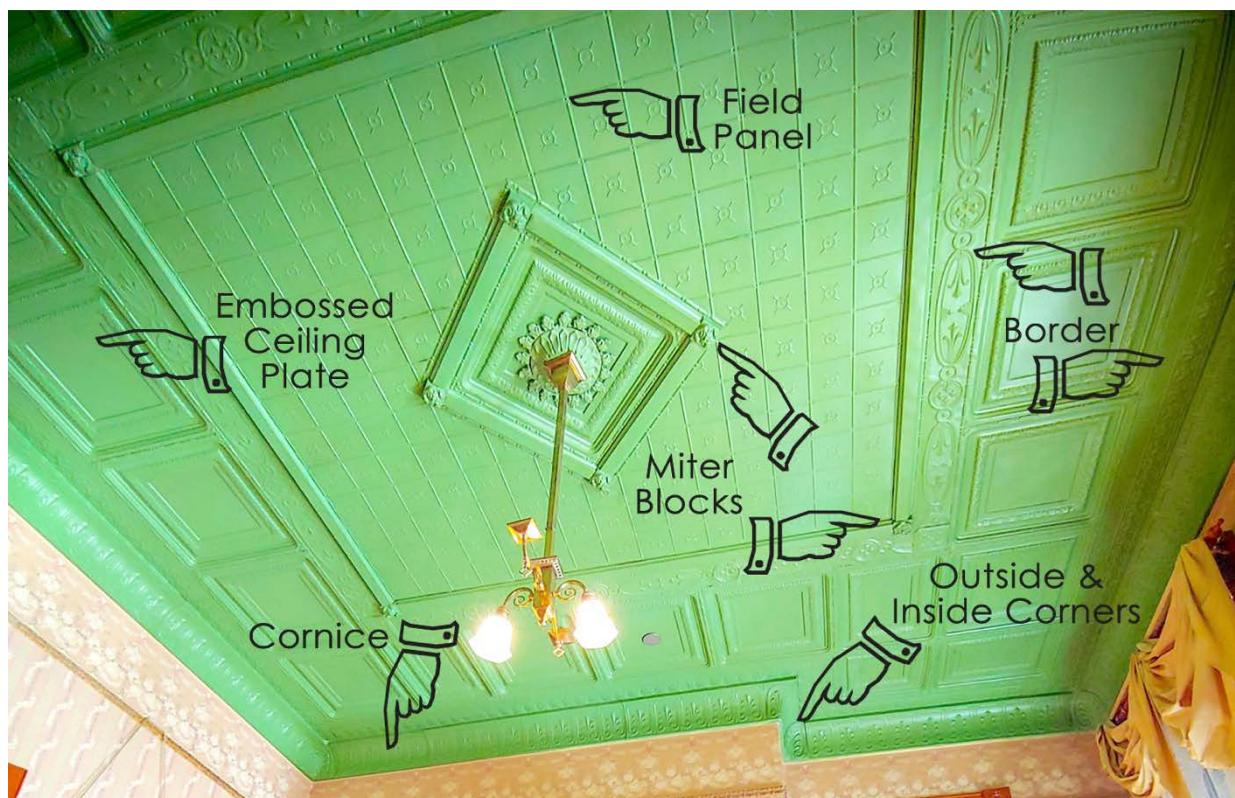
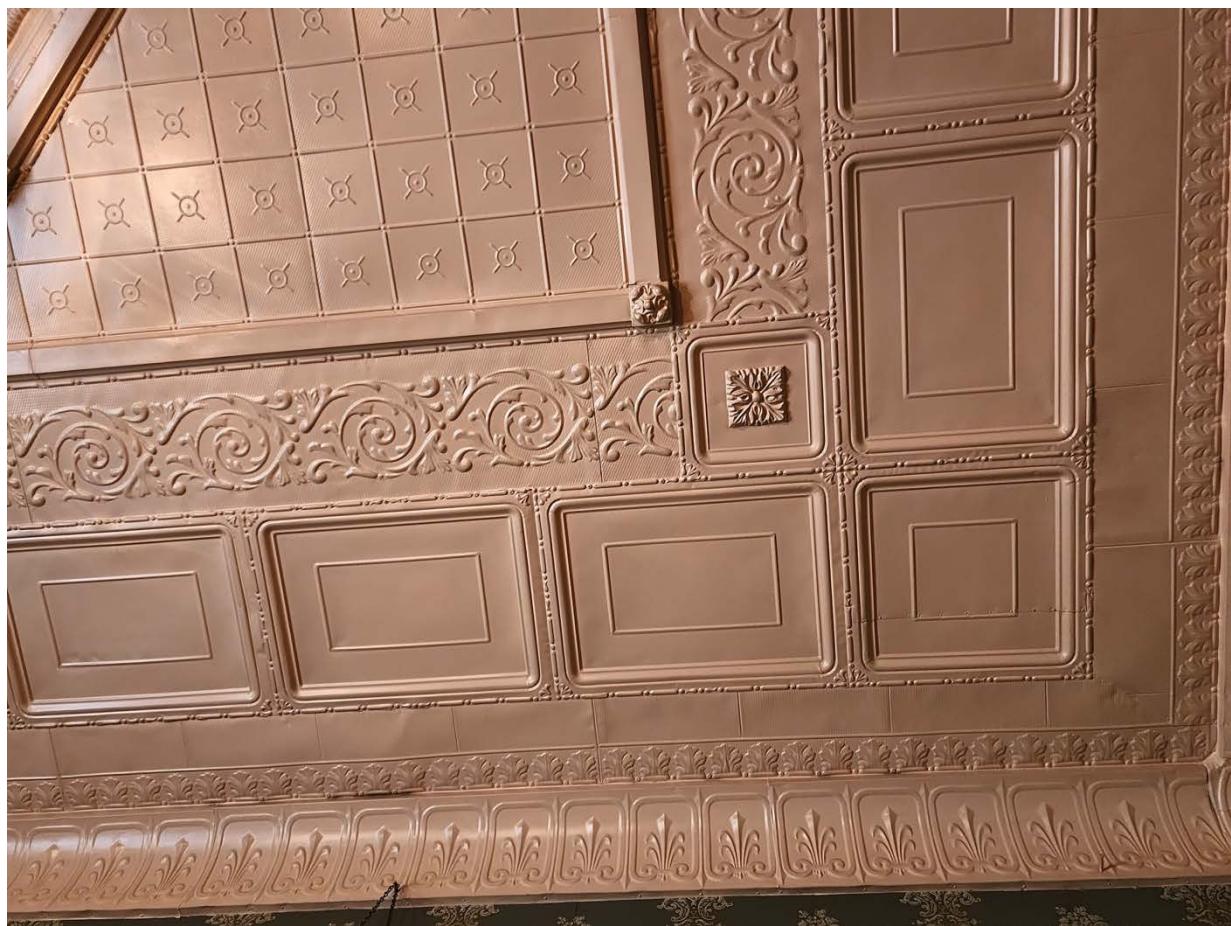
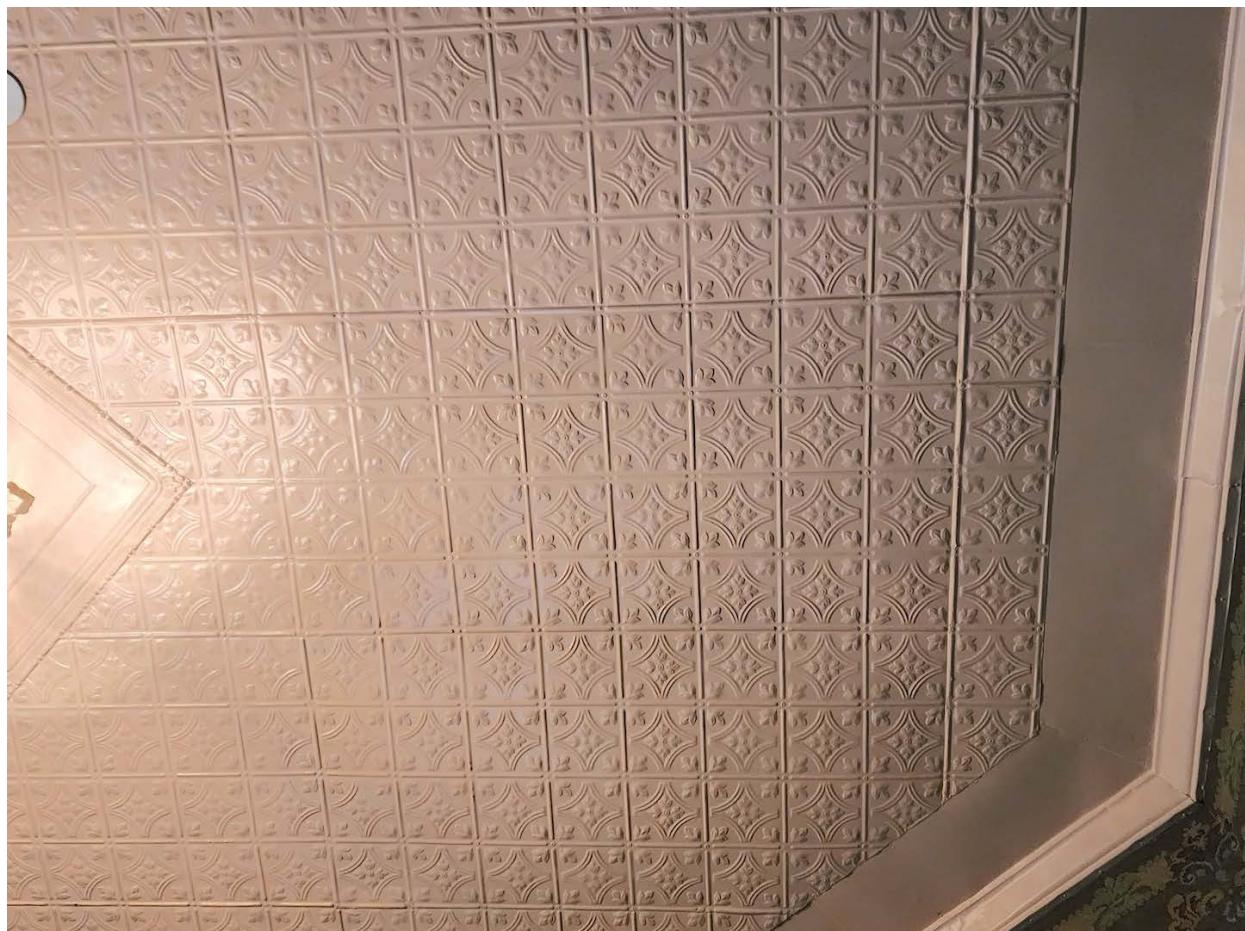
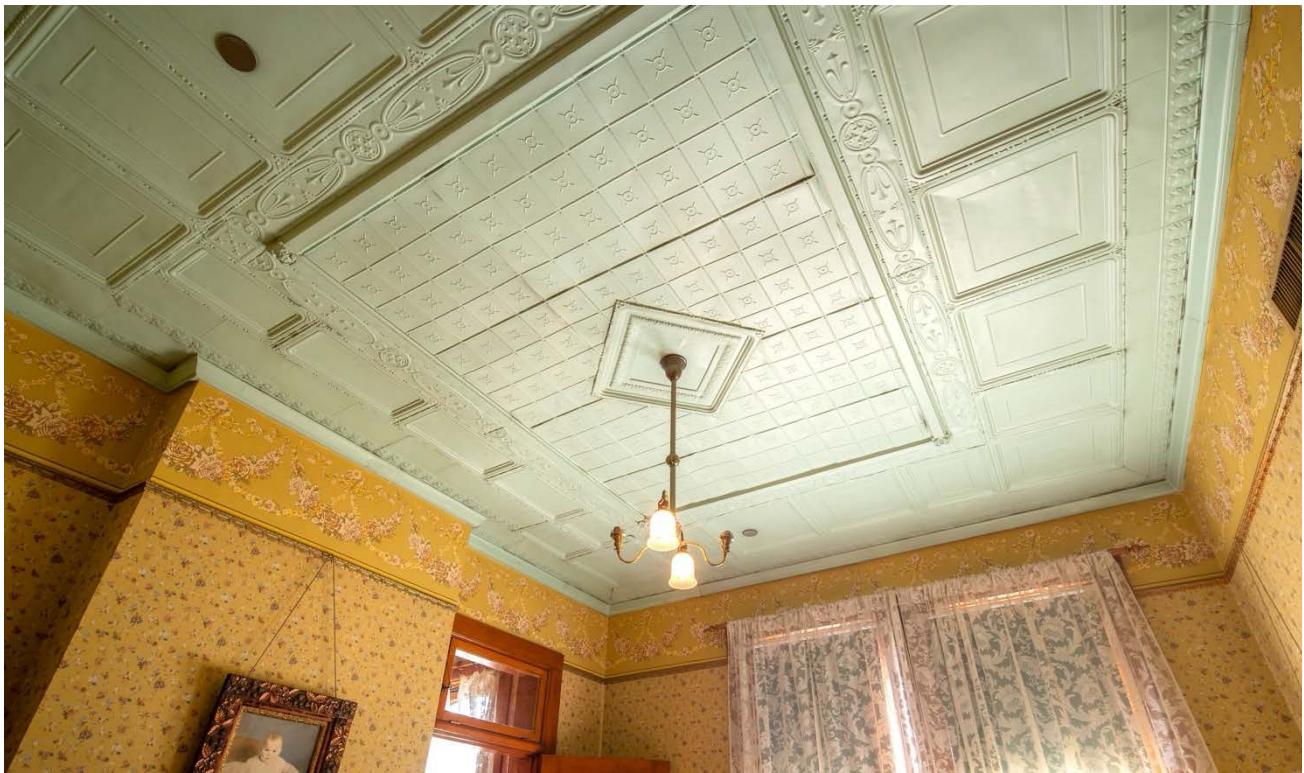
Composite Image - Catalog pages 24, 26, and 27

We found many of Rosson House's original, ornamental metal ceiling elements in the [1890 Kinnear & Gager Co. catalog](#). On the next page is a composite image from the catalog that shows many of the ceiling pieces you'll find at the home, along with an image of our dining room ceiling, pointing out many of those same pieces. The remaining pictures on the following pages are of the ceilings of the Rosson House family parlor, doctor's office, and nursery, in that order. We believe the doctor's office ceiling was originally purchased from the Wolf Steel Ceiling Co. (as shown in their [1910 catalog](#), page 4).

No. 13. Intermediate.
Depth, $\frac{5}{8}$ inch. Size, 2 ft. by 2 ft.
No. 12. 1 $\frac{1}{2}$ ft. by 2 ft.
No. 11. 1 ft. by 2 ft.
No. 10. 1 ft. by 1 ft.

No. 38. Shallow.
Depth, $\frac{5}{8}$ inch. Size, 2 ft. by 2 ft.
No. 39. 1 ft. by 2 ft.
No. 40. 1 ft. by 1 ft.
No. 41. 1 $\frac{1}{2}$ ft. by 2 ft.

No. 2. Embossed.
Size, 2 ft. by 2 ft. Depth, 1 $\frac{1}{8}$ inch.

No. 102
Size, 2 ft. by 2 ft.

No. 113
Width, 3 $\frac{1}{2}$ inch to 15 $\frac{1}{2}$ inch, 4 ft. long.

No. 114
Width, 2 inch to 15 $\frac{1}{2}$ inch, 4 ft. long.

No. 115
12 inch wide x 4 ft. long.

No. 120
6 inch wide, 4 ft. long.
